Project Report for the year 2009

A Work in progress: continuation of the
**Yaqan Nuki Wetlands Friendship Society's Rehabilitation
of the Lower Kootenay Band Wetlands
Creston, B.C.**

**Yaqan Nuki Wetlands Rehabilitation Projects
Creston B.C.**

This summary addresses the rehabilitation upgrades realized this year, inclusive to October 30, 2009

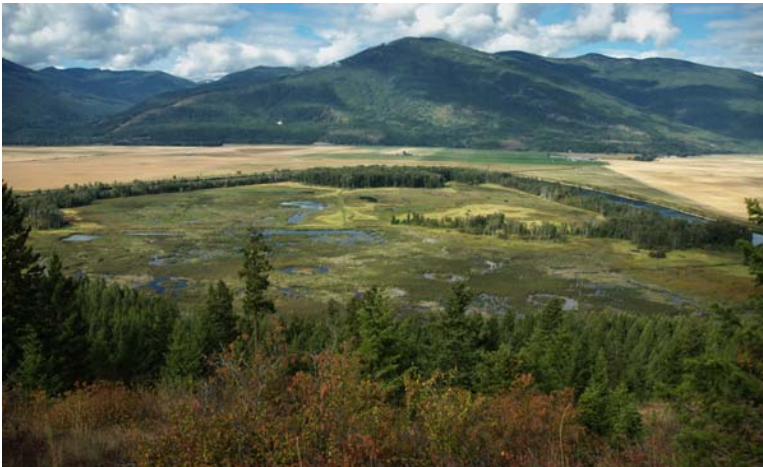
Tanal Marsh summer 2008

The plan to keep consistent high water levels (3 feet +) in Tanal marsh for a five year period to drown out cattails and interfere with production of new plants is, so far successful. (see photos above).

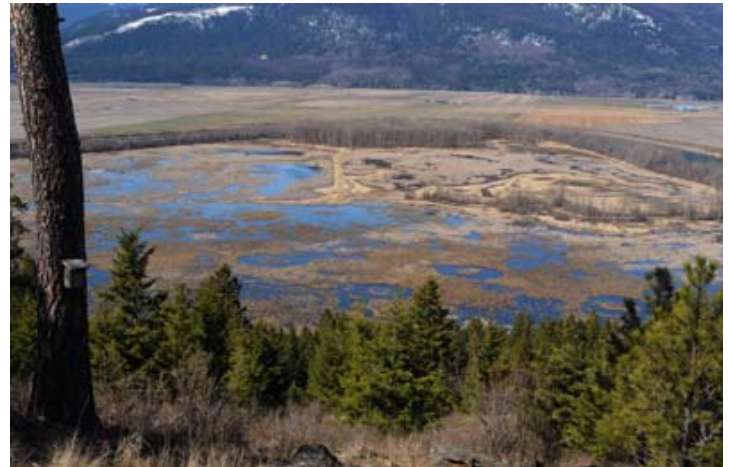
Tanal Marsh May 2009

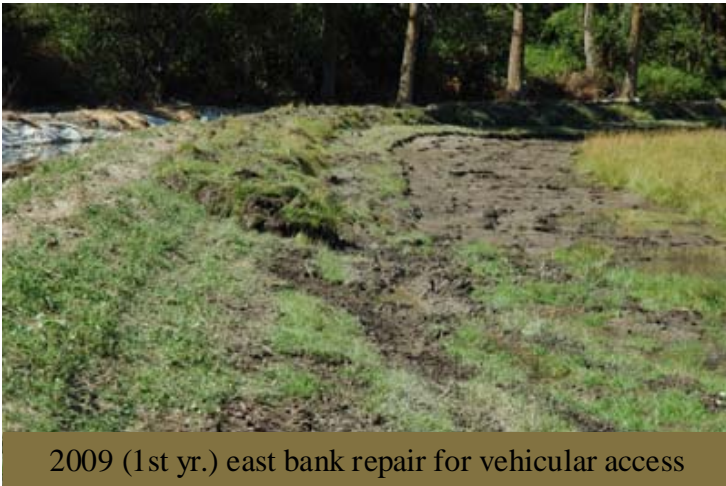
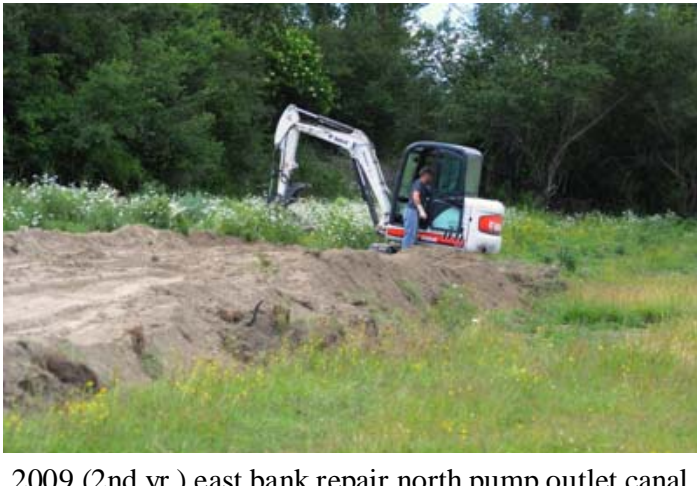
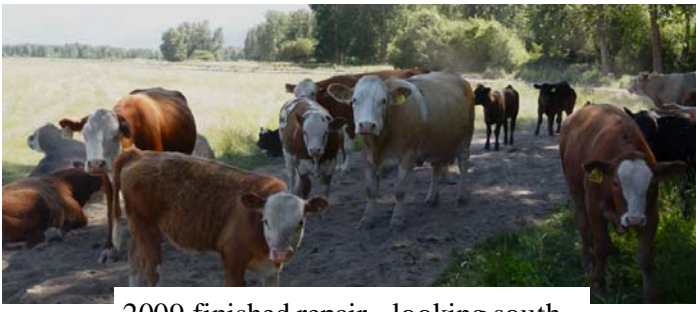
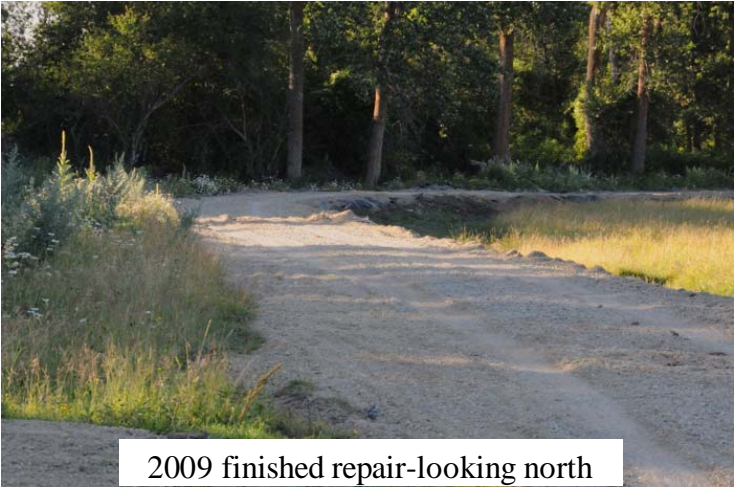
North pump canal repair

2009 finished repair - looking south

2009 finished repair-looking north

Repairs, this year, were begun by establishing an onsite borrow pit and utilising the materials thereof for the bottom build-up layer of the desired east bank dry maintenance access lane. Its length is approximately 1200 meters, and completed project height is approximate to that of the canal's existing east bank. Following the first layer described above, barrier cloth was applied, and the whole over-laid with crush.

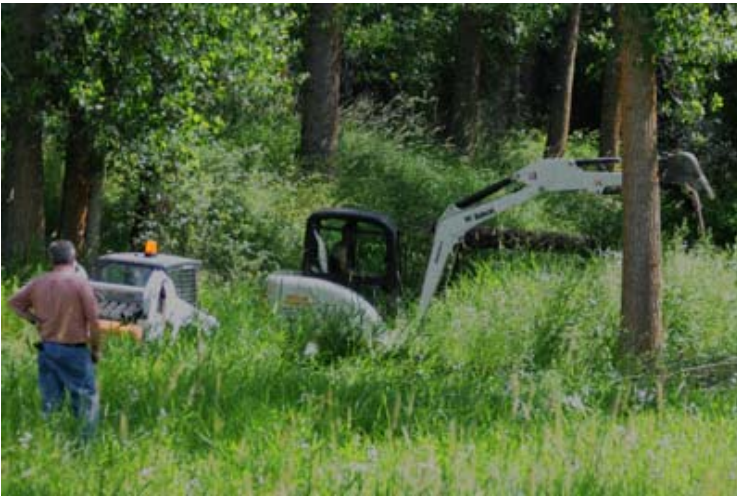
Clearing out canal

Repairs this year were begun by establishing an onsite borrow pit and utilising the materials thereof to build-up, by approximately 2 vertical feet, the east bank of the Band pump secondary canal to Skincus marsh. The existing canal was cleaned out of debris and fallen trees from winter storms. Build-up length was approximately 1200 meters, starting at the Band pump outlet culvert. Geotech fabric was applied over the new elevation height and down the inside canal bank and floor. This step was followed by aggregate as topcoat, to prevent erosion and establish better compaction and stability. Degradation was almost immediately evident when cattle trails were seen leading west to east across the canal two days latter. To prevent further damage, a pole and barbed wire fence was installed around both sides and ends of the project.

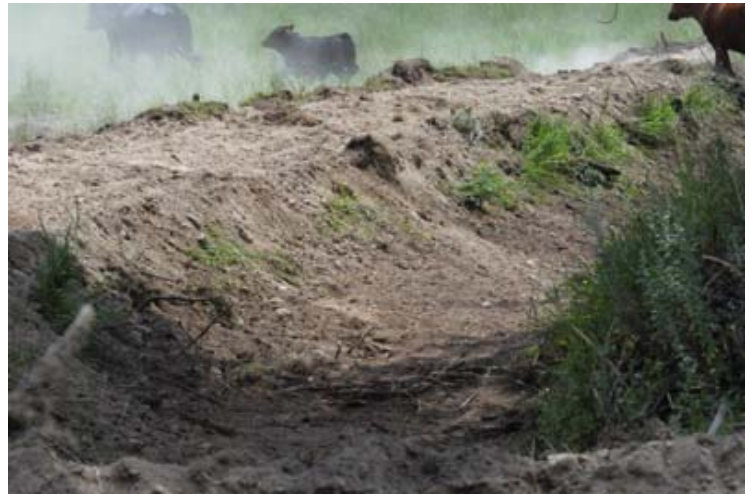
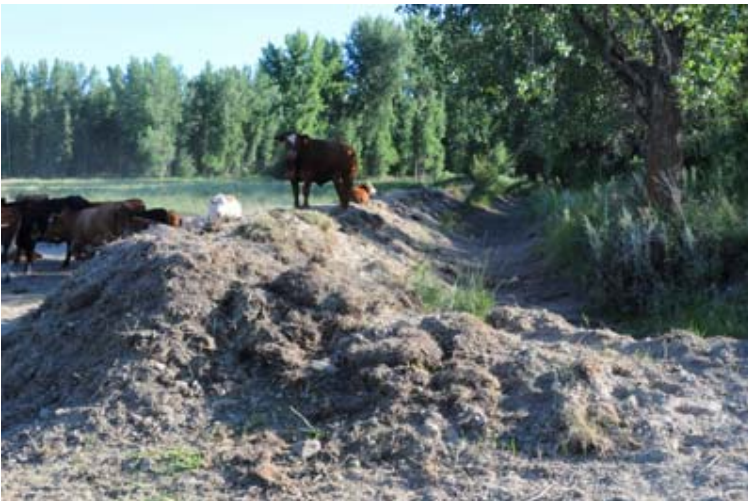
East side canal berm

Berm completed

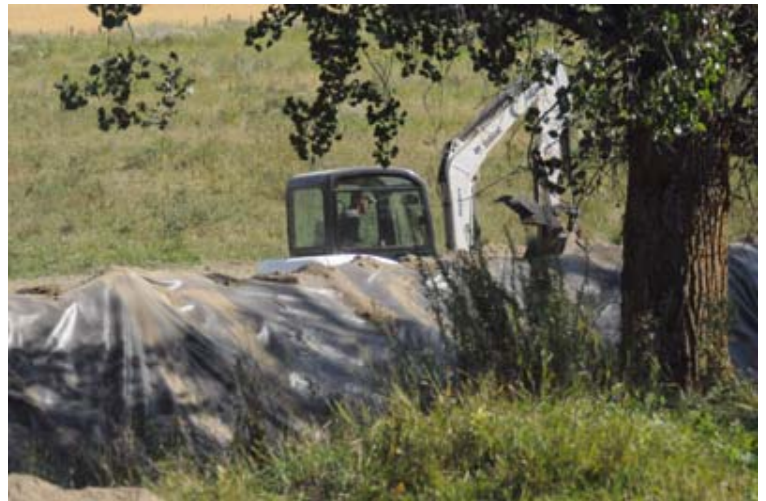
Geotech cloth application
