A Work in Progress: Continuation of the  
**Yaqan Nuki Wetlands Rehabilitation Project**  
**Creston, BC**

Continuation of the  
**Yaqan Nuki Wetlands Rehabilitation Project**  
**Creston, BC**

This summary is designed  
as an addendum to the March 2005 report  
and includes rehabilitation up-grades inclusive to November 30, 2005.

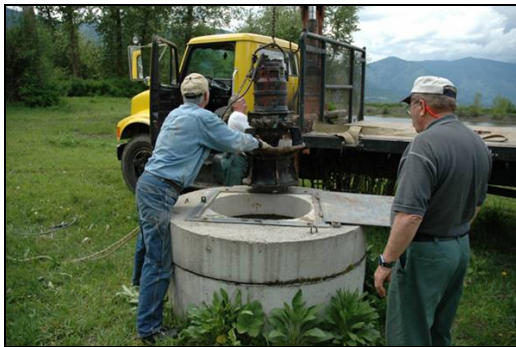
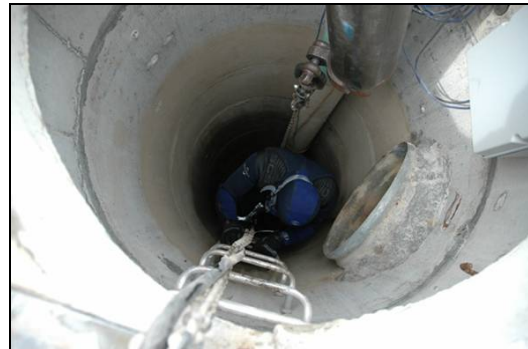
We serviced the Middle Pump, was serviced in the spring but it was pulled up again as it would still not operate. The electrical hook-up to this newer pump and a submersible is far more sophisticated than the other pumps. We called in an electrician who was able to start-up the pump again (Figure 1).

**Figure 1: Middle Pump re-install at Skincus Marsh May 2005.**

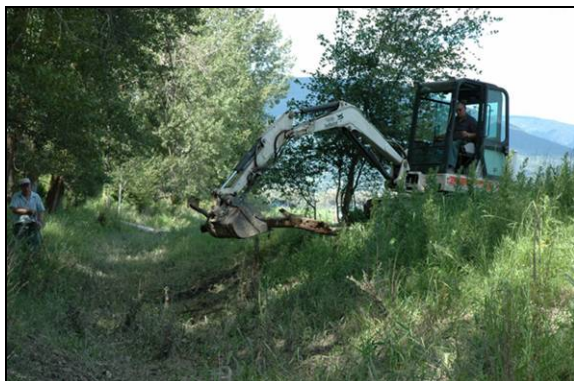
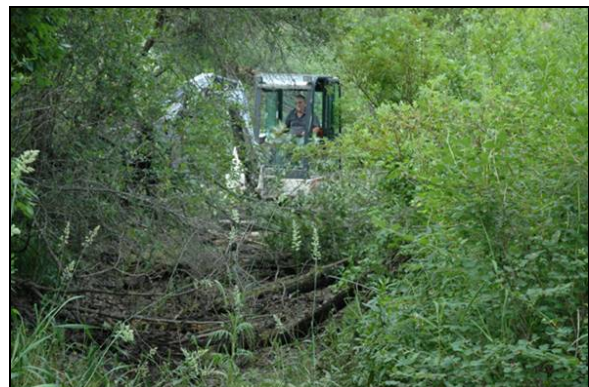
We discovered that the original pumping infrastructure had incorporated a canal linking the Marsh system to one of the Lower Kootenay Band's excess water outlet systems (installed to maintain arability to adjacent farm lands). About a half kilometre long, it joins the Middle Pump canal that feeds Skincus (Coyote) Marsh (see Appendix 1 for map), entering a few yards from the pump source. We doubt it was ever used much. We found it had a raised bottom height from partial blockage due to fallen trees/wood/debris, and eroded banks from years of cattle trails.

On our initial water test there was back-flow and subsequent over-flow onto the farm land. An old culvert with flap door was found near the outflow terminus. Its diameter, which is smaller than that of the source flow, was also incapable of flow without back-pooling. However, the culvert was found to be unnecessary for flow control so we removed it. Now the canal has been restored to proper working order (Figure 2). The Middle Pump and the band canal link are now functioning, so the commencement of water restoration to Skincus Marsh began.

**Figure 2: Canal repair – Band Pump to Skincus Marsh July 2005.**

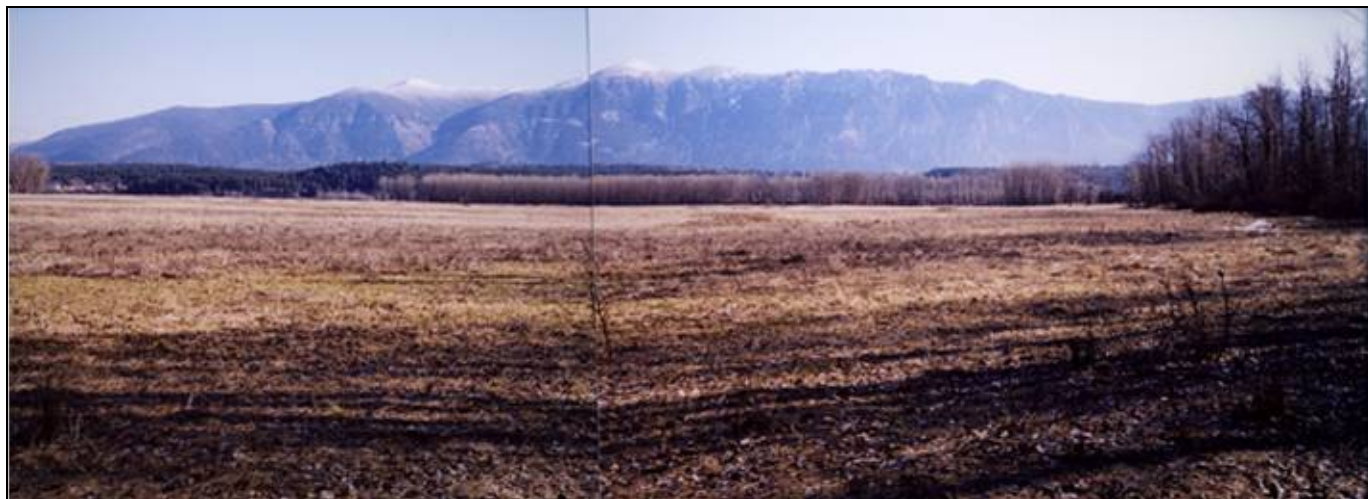
**Figure 3: Skincus Marsh – dry bed February 2005.**

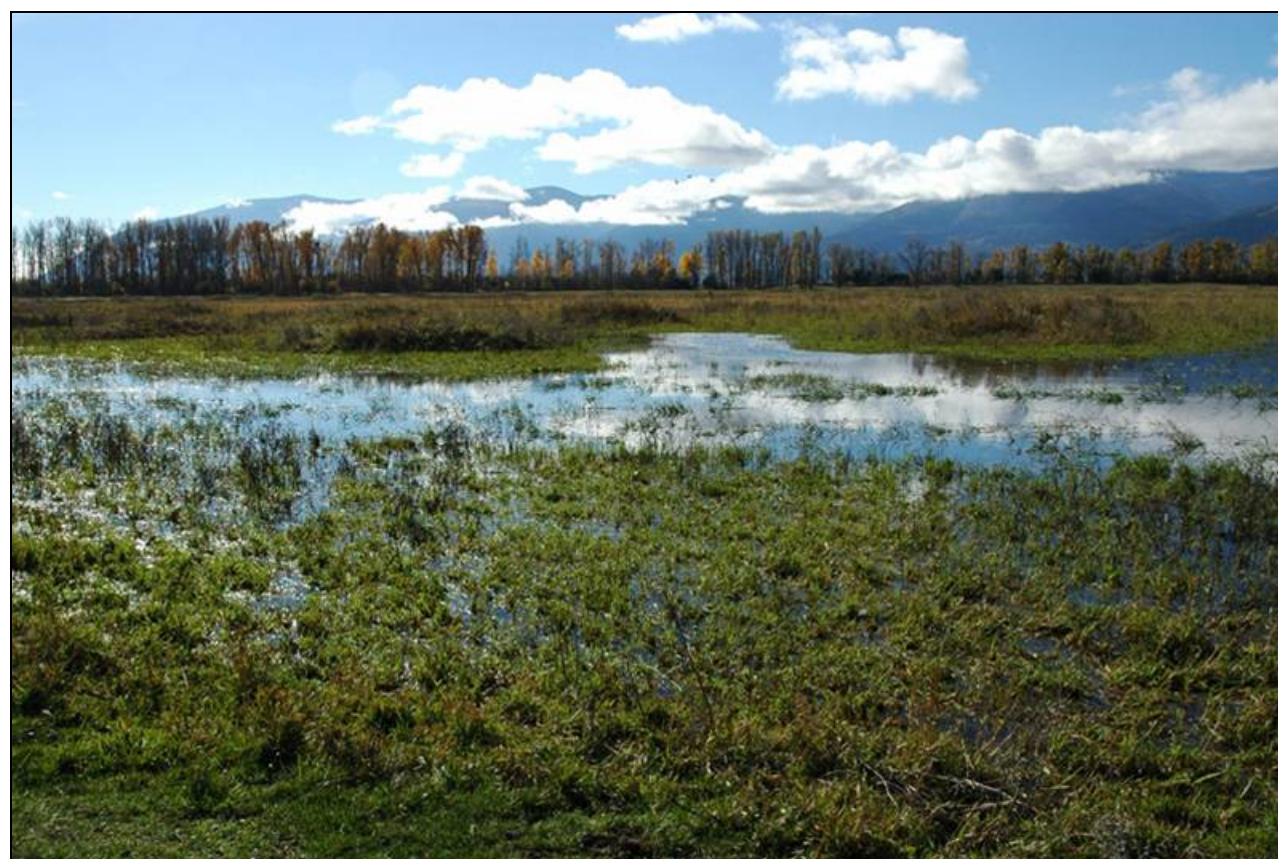
**Figure 4: Skincus Marsh – restored October 2005.**

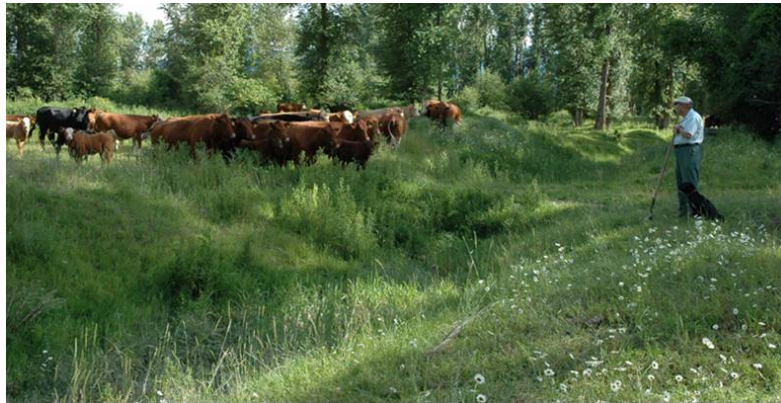
**Figure 5: Taking stock of canal at culvert site July 2005.**

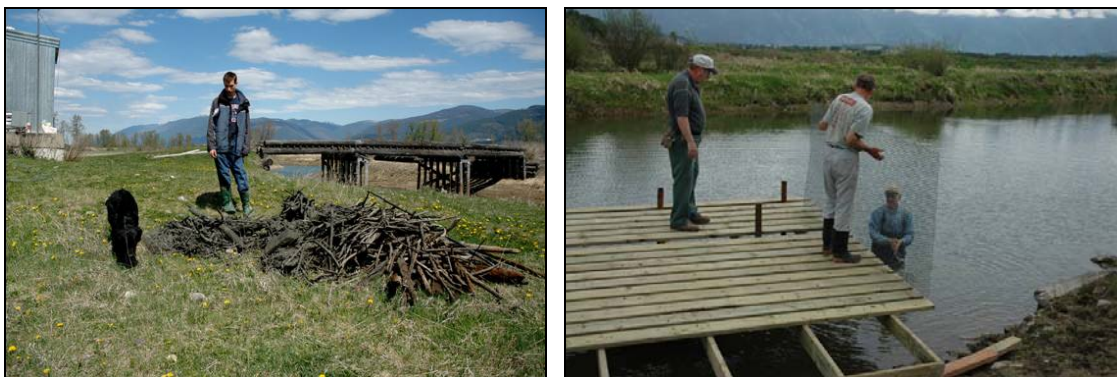
The next step was to repair to the intake culvert at the North Pump. In 2004 floating milfoil was continually clogging the screened entry, triggering pump failure and a subsequent need for repeated re-start. This necessitated crop harvesting intervals. A look into the 30 foot “well” leading from pump floor to the proximal end of the intake culvert revealed wood/log/debris up to 4 inches in diameter and 3 feet in length. The existing inlet screen was probably a late application. We brought in a sump pump to clear the water from the chamber, and removed the debris by hand. We then installed a screened area 5 feet beyond the culvert mouth and sides to the bank and the original screen was left in place. We built a planked jetty to allow for easier access to milfoil for harvest when needed (Figure 6).

**Figure 6: North Pump debris from the intake well April 2005 (left) and screening and jetty for milfoil control May 2005 (right).**

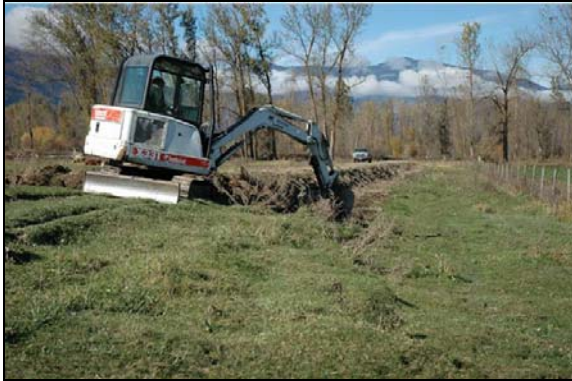
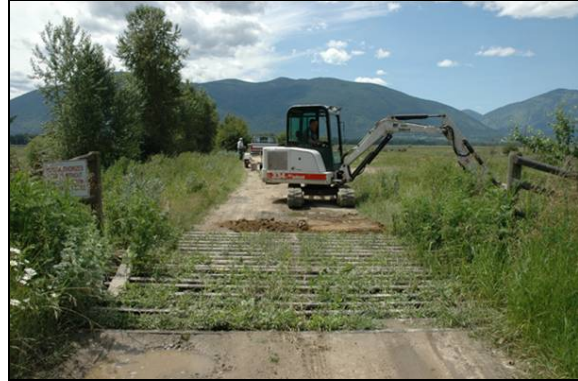
Generally the dykes had not been repaired or maintained for many years. The cattle guard entrance to the two dykes leading to the North Pump was partially covered so we repaired it (Figure 7). The east-west dyke in Tanal Marsh was impassable by vehicle due to erosion and/or undermining (partly from muskrat activity over the past 30 plus years). We filled the holes. However, a layer of gravel is needed for it to be passable in wet weather since slick mud renders access for pump maintenance dangerous to impossible when it rains. This is also a problem with the two dykes leading to the north and Middle Pumps. It was not rectified in 2005.

**Figure 7: Cattle guard repair July 2005 and Skincus Marsh dyke repair October 2005.**

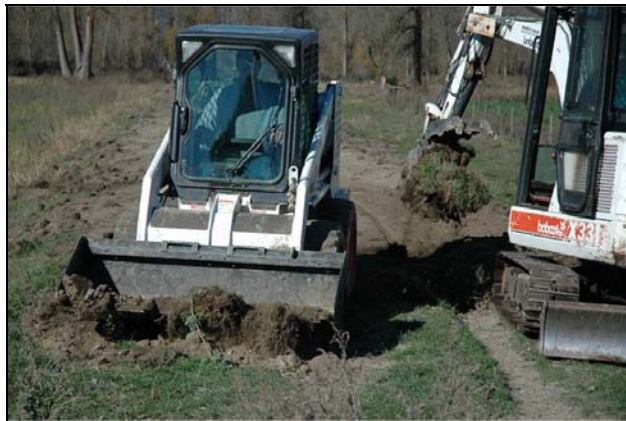
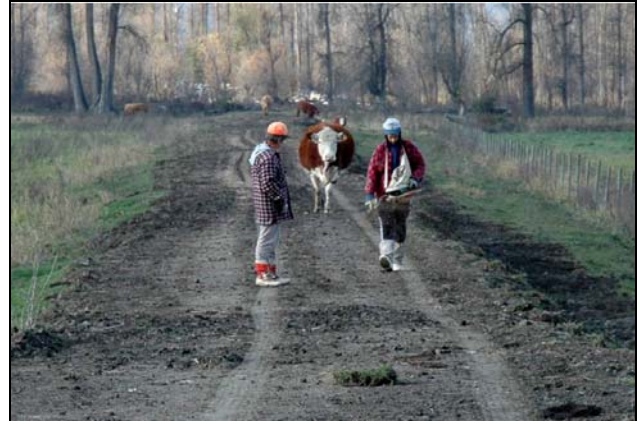
After Skincus Marsh was restored to its traditional water levels, we consulted with a Duck's Unlimited representative. It was determined that the containment dyke (approximately 600 meters in length) at the east end of Skincus was no longer stable and there was a concern it would give way, flooding farm lands in the process. It was thought to have been overflooded at one time, eroding the banks. It has been further compromised by the herds of cattle using the dry basin for foraging over the years. We repaired the dyke and then seeded it for continued stabilization (Figure 8).

**Figure 8: Skincus Marsh dyke repair (left) and seeding (right) October 2005.**

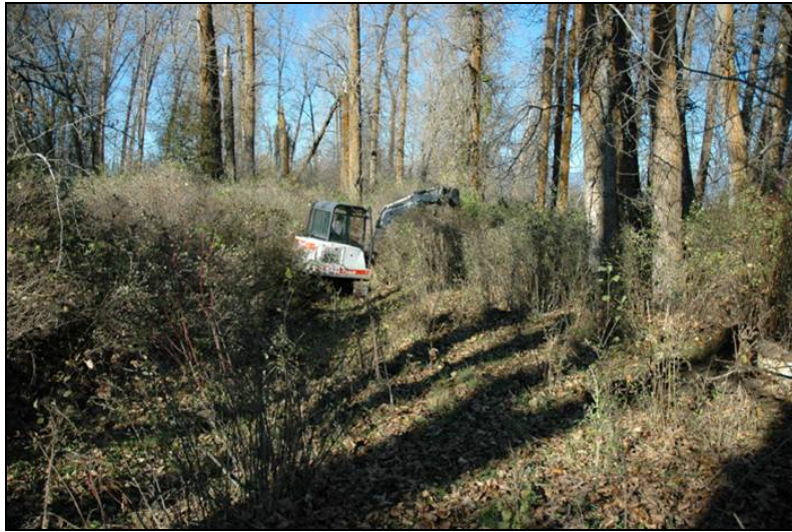
The North Pump outlet canal, water access for Kupa Marsh and Hidden Lake, leaked over its banks during pumping, with resultant spillage to cattle grazing land. Debris has raised the height of the bed over the years. To correct this structural failure, we deepened it by two feet for about 300 yards (Figure 9).

Figure 9: North Pump outlet canal cleanup and deepening October 2005

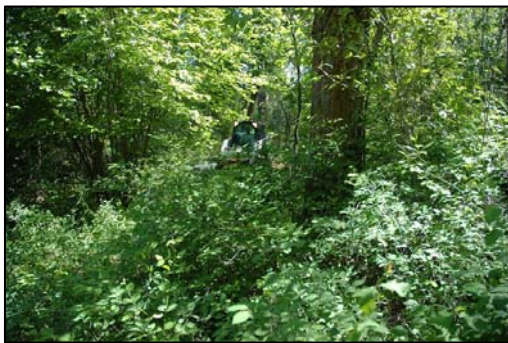
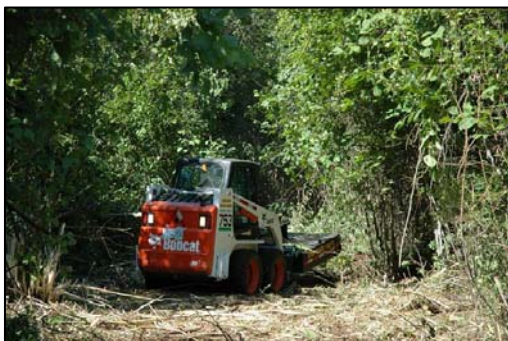
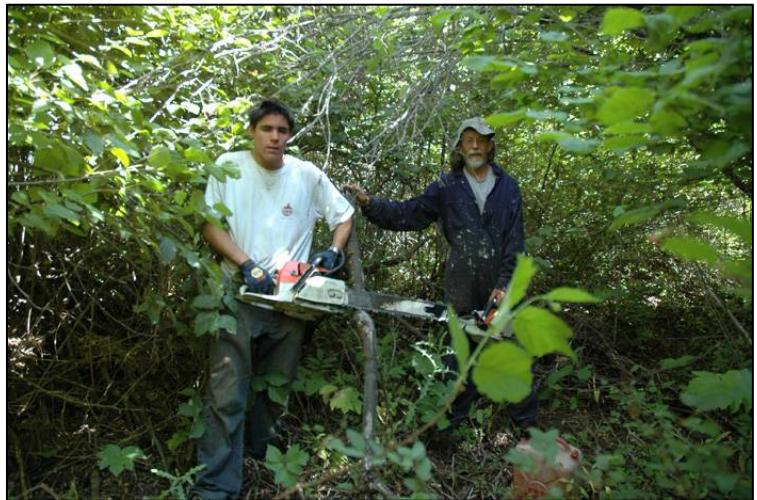
The north-west compartment of Tanal Marsh tended to loose more water than the others, and was very difficult to monitor. The band leaders informed us that there was an old vehicular trail along the back (river side) of that compartment that hooked up with the east-west dyke, when the original infrastructure was put in. They requested it be re-established for maintenance and accessibility. We cleared the road for a total distance of approximately 3 kilometres (Figure 10).

Figure 10: Reconstitution of old Tanal Marsh river trail from pump house and connecting with west end of E/W dyke

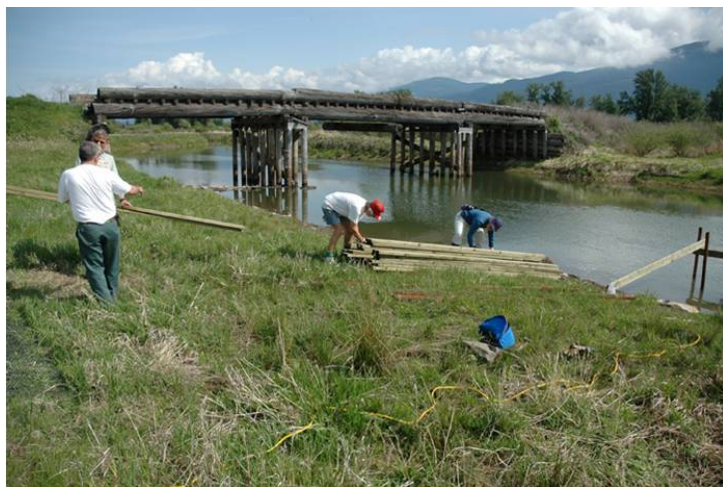
Investigation found that there is no other route that can be taken for vehicular maintenance of Happy Hunting Ground Marsh dykes other than the old bridge that crosses Indian Creek, which borders two sides of the Marsh. The creek widens toward source, always with steep mud banks. It empties into the Goat River, which forms the third side of the Marsh. The fourth (east) side is a maze of springs feeding the creek and has no stable ground. Cost of a new route would be prohibitive.

We undertook to investigate the degree of rot in the bridge pilings in order to determine rehabilitation feasibility. The outer pilings (both sides) were found to have 30-40% rot at the “tidal line”. The inner ones are good at 10%. The planked bridge deck had been removed previous to YNWFS intervention, apparently to stop cattle from crossing. The deck support logs are rotten. The bridge, which was originally 12 feet wide and 100 feet long, could be refurbished at 8 feet wide, thus excluding the outer pilings. The machinery utilized by the Society (e.g. bobcat and pickup) is far lighter than that used during the initial Marsh infrastructure construction, when the bridge was built (Figure 11).

**Figure 10: Indian Creek bridge by North Pump inlet (left) and bridge inspection for piling rot October 2005 (right).**

Bridge repair for vehicular maintenance access to Happy Hunting Ground Marsh is expected to be a summer project. At this point in time, the bridge deck support logs are being donated and the deck boards, partially donated.

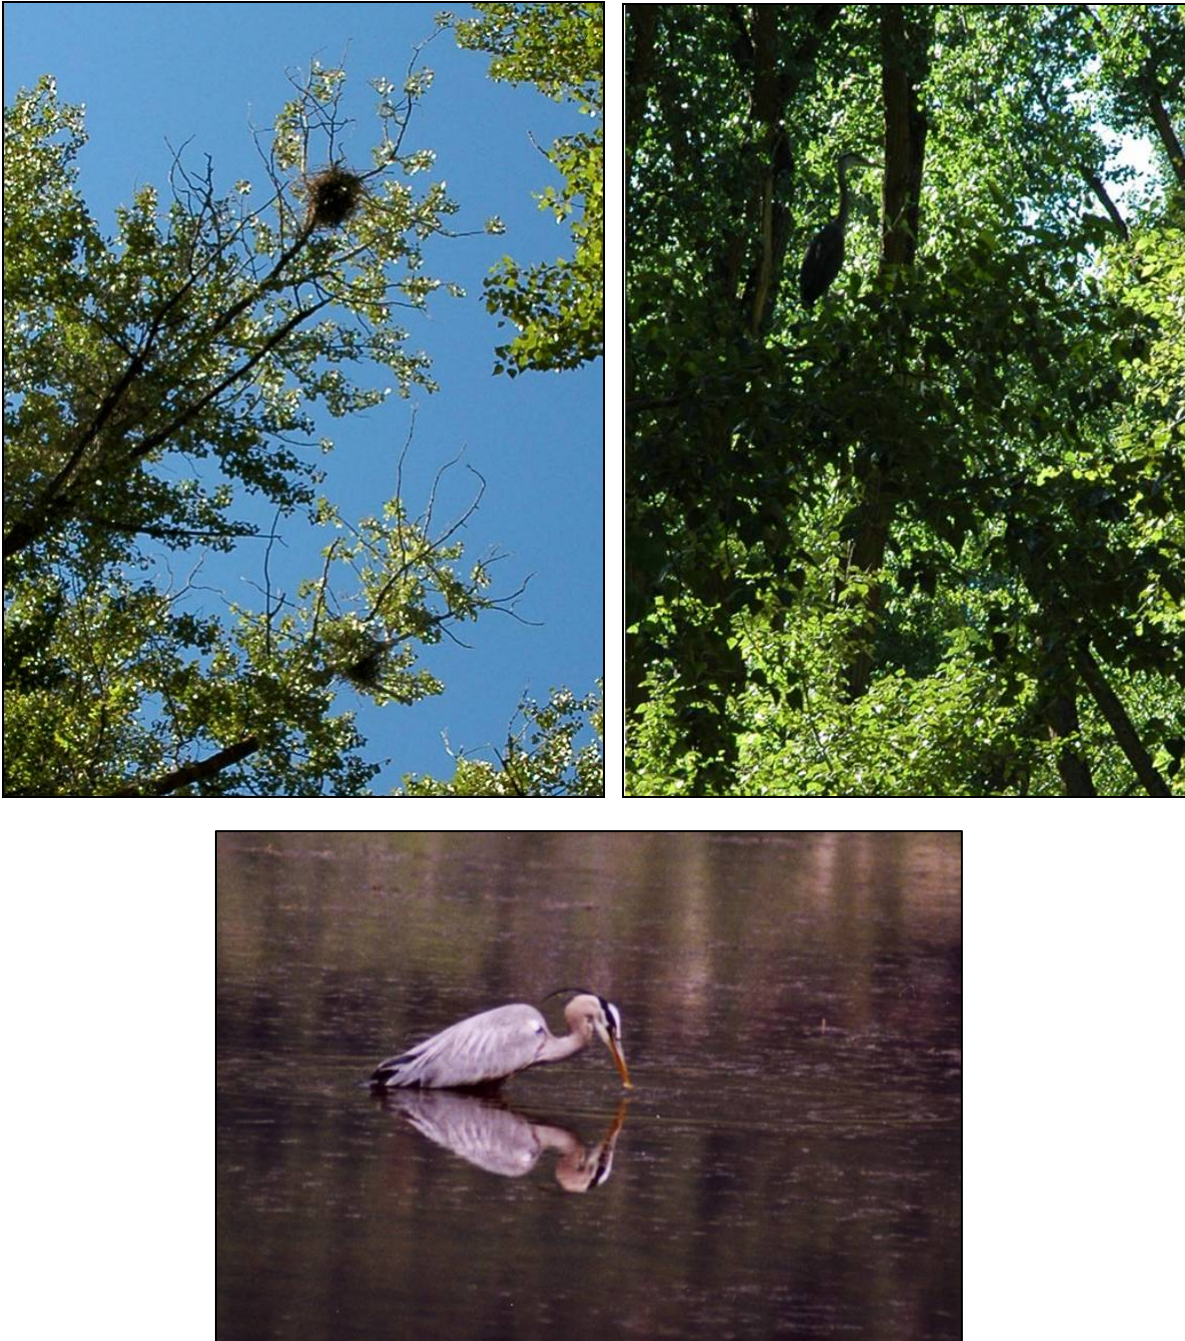
More Great Blue Herons were noted in 2005 in Tanal (Cattails) Marsh than had been observed since our rehabilitation process had begun. A new rookery (eight nests) was found in the dense cottonwood forest at the west end of the marsh (Figure 12)

Figure 11: New Great Blue Heron rookery at Tanal Marsh May 2005.

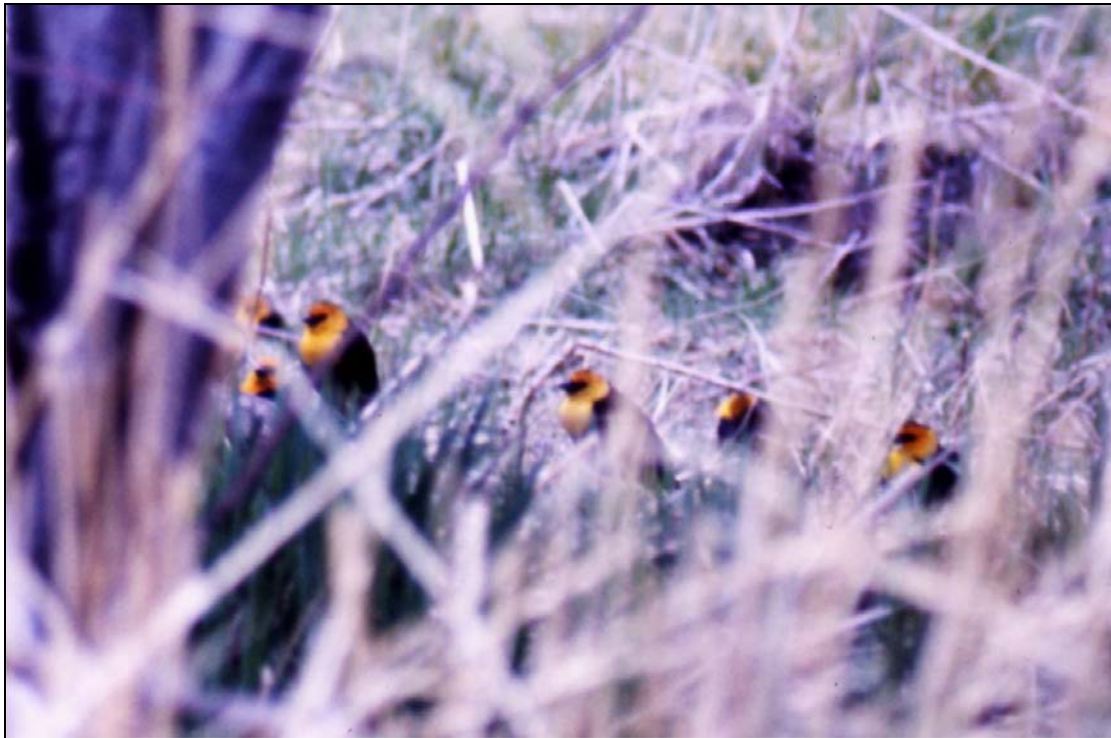
Amongst marsh nesters, the Yellow-headed Blackbird is most unforgiving when its habitat has been destroyed. It is, therefore, extra special that these birds have chosen to reappear in traditional force (Figure 13).

**Figure 12: Yellow-headed Blackbirds at Tanal Marsh August 2005.**

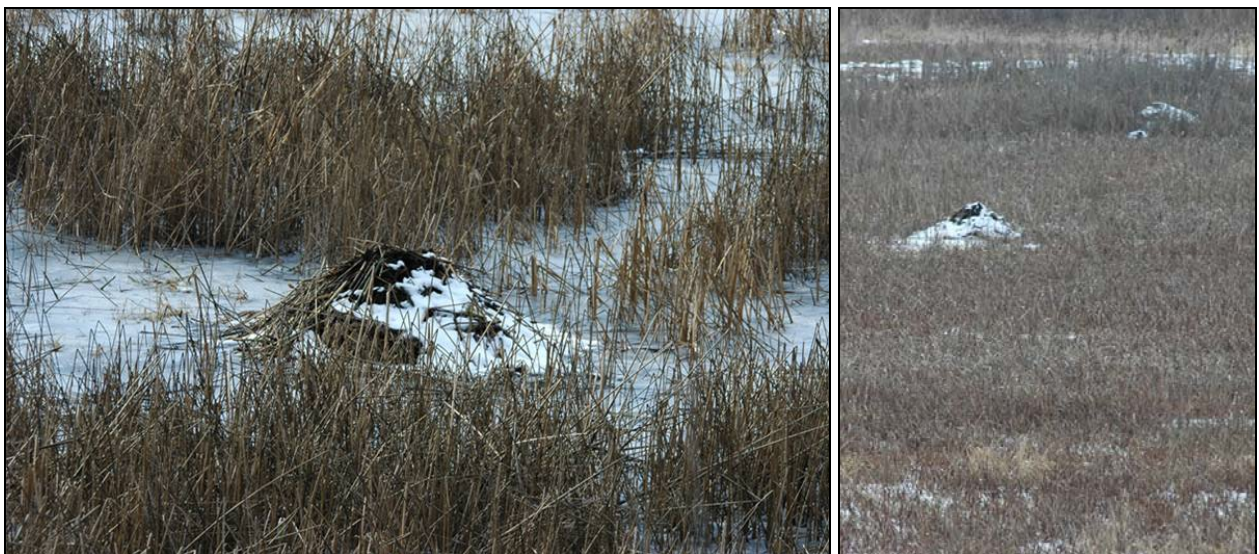
The muskrats are back! Suddenly in the beginning of October 2005, their mud houses began to reappear, thirty-plus Tanal Marsh and eight in Kupi Marsh (Figure 14). These animals are proficient in cattail control. With their help at the harvest, marsh health will increase.

**Figure 13: Muskrat Houses Tanal Marsh**

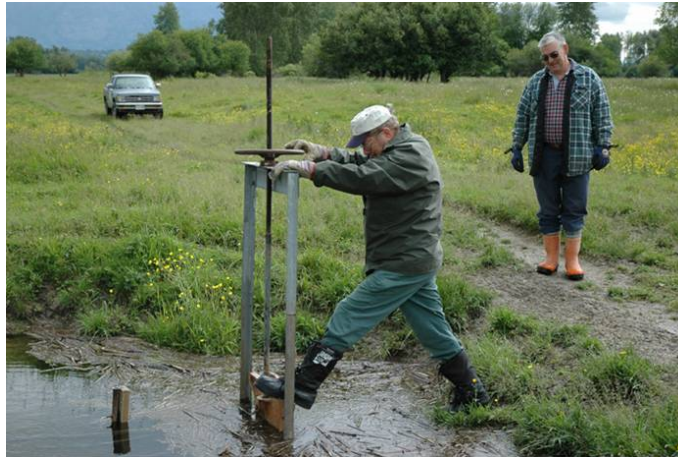
The Short and Long dyke accesses to the North and Middle Pumps, plus the dykes at Tanal Marsh were mowed in the early spring. The three pumps were inspected 1-2 times a week and greased as needed. The North Pump needed to be restarted a few times following electrical storms. There was no problem with milfoil after the fenced enclosure was erected. Water levels were monitored routinely (Figure 15).

**Figure 14: Monitoring water level control at canal to Hidden Lake.**

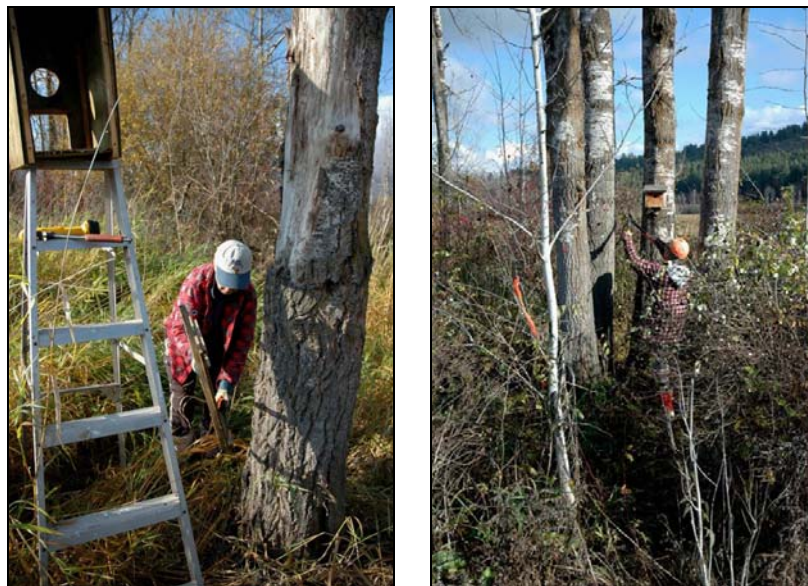
Bird boxes were monitored and repaired as needed. Marsh inhabitant activity was monitored (Figure 16).

**Figure 15: Duck box repair and nest inspection.**

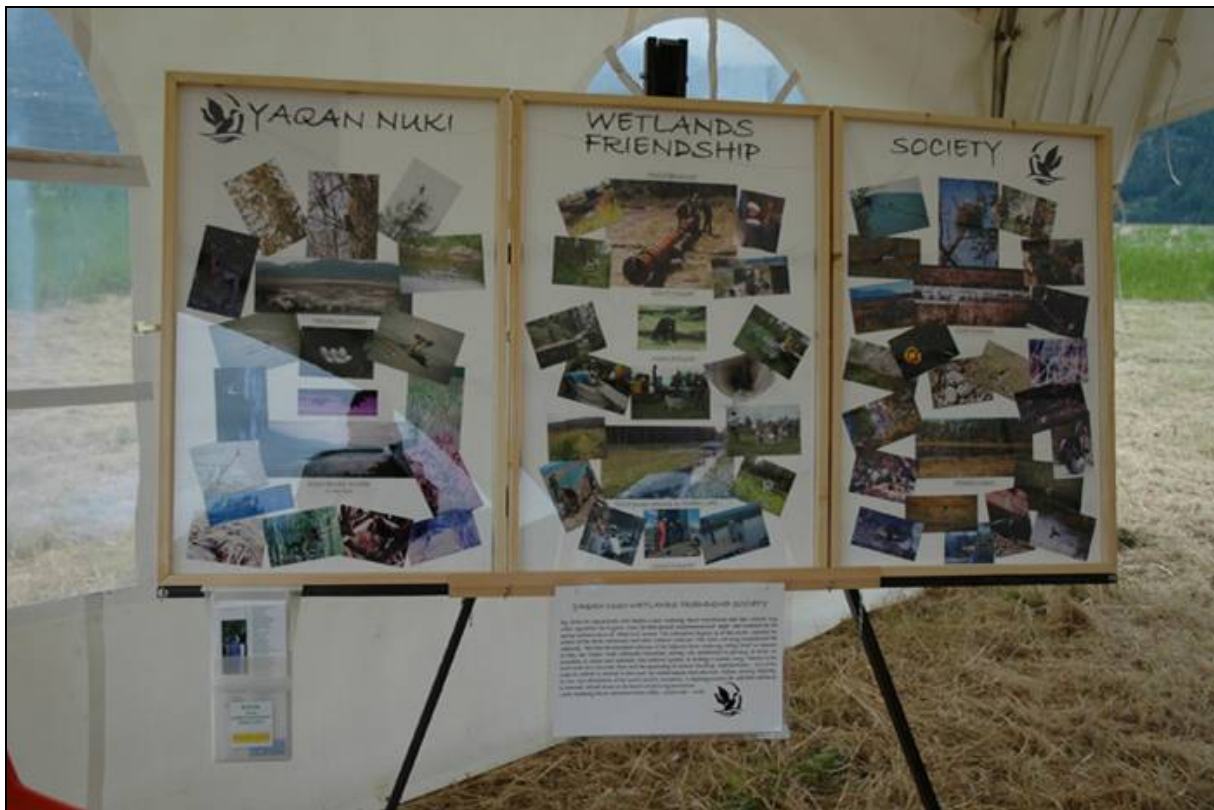
The 60<sup>th</sup> anniversary celebration of BC's Commitment to Wetland Conservation was hosted by the Creston Valley Wildlife Management Area (CVWMA) in 2005. Our Society was an active participant and a member of the organizing committee. A display of the YNWFS wildlife and its restoration improvements was exhibited along with bird brochures and a short history. The case for the display was made in three wood frames hinged together to fold and lock as a suitcase (Figure 17). The three display compartment illustration boards slide out which enables upgrades and can be a basis for enlarging a "library" of pictured teaching aides that is also portable. The unit was given to the Lower Kootenay Band administration to be made available to the school.

Figure 16: Teaching display 60<sup>th</sup> anniversary celebration of BC's Commitment to Wetland Conservation
